Report on the investigation of the loss of the sailing yacht

***Ouzo***

South of the Isle of Wight

**Report No 7/2007**  
**April 2007**

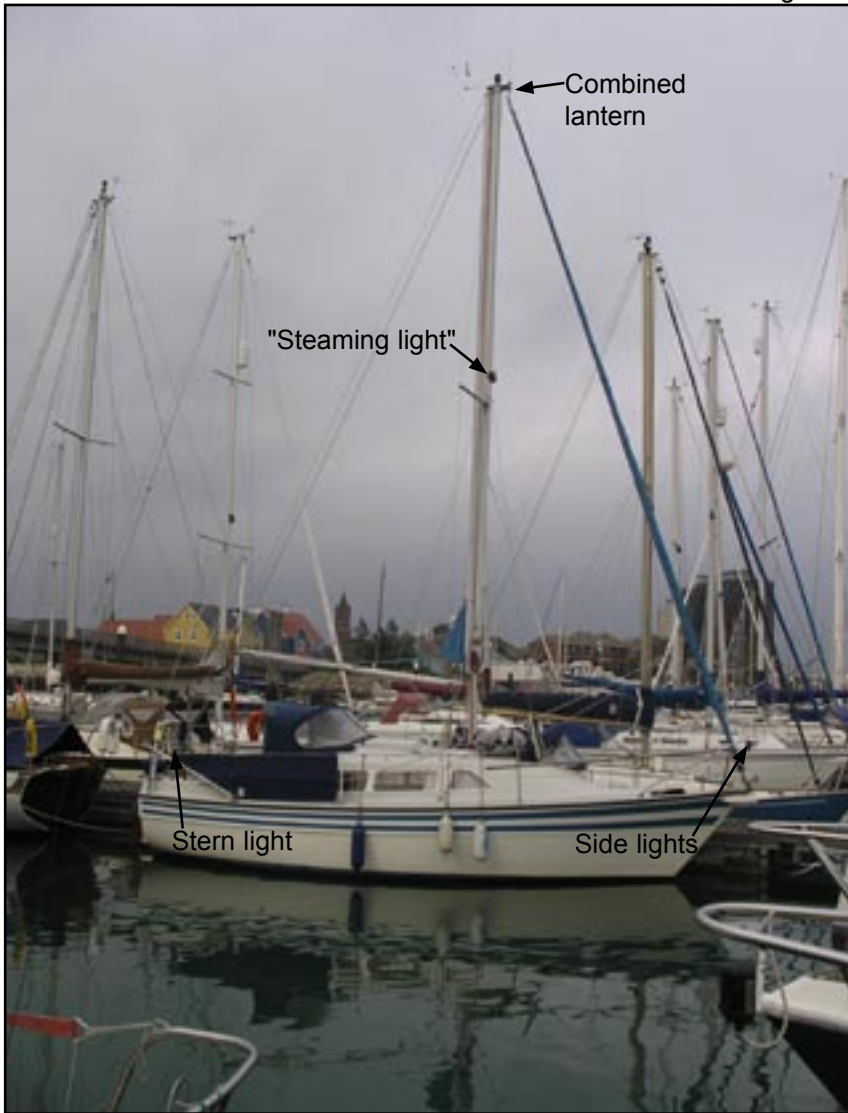
Figure 8

Navigation light arrangement

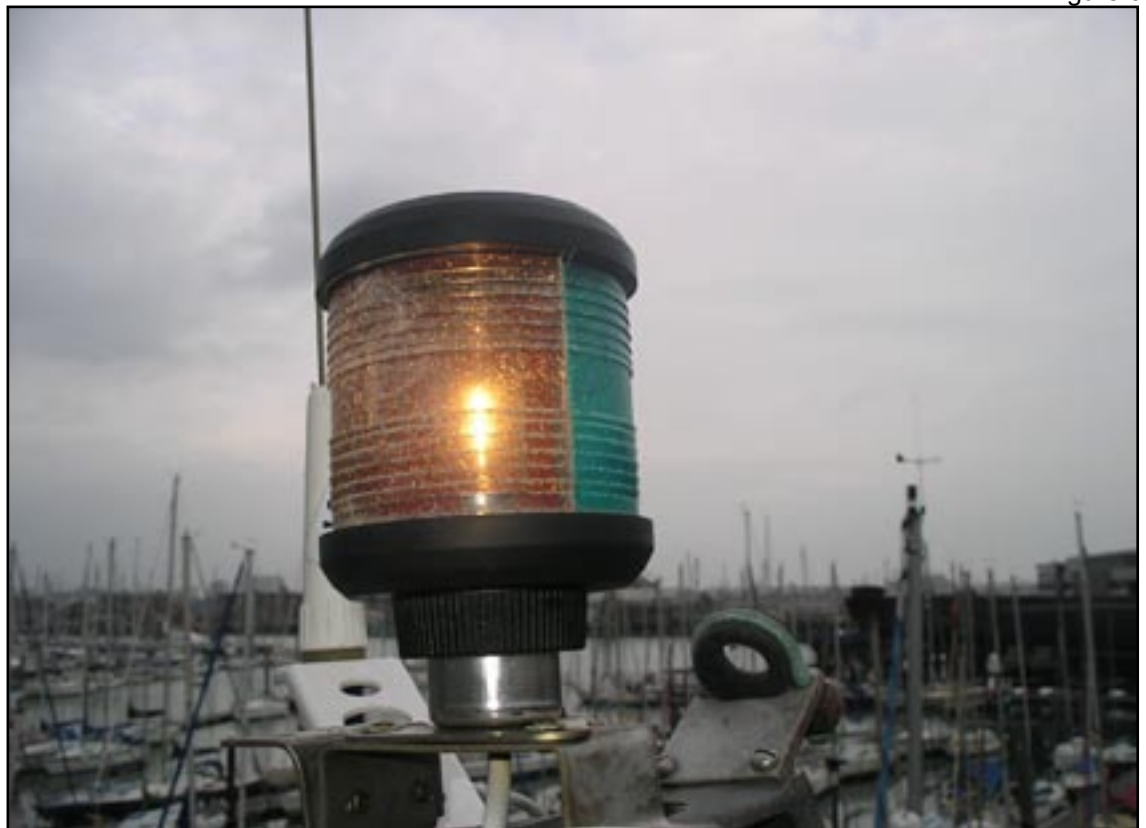
Figure 9

The investigation found that after a period of time, the lenses of combined plastic masthead units are prone to crazing as the plastic becomes diffuse due to heating from the lamp (bulb). This reduces the luminosity of the light (**Figure 9**).

The condition of the lights aboard is not known, but the unit had not been replaced since the boat was built. **Figure 9** shows a unit of similar age to the one on board *Ouzo*.

Combined top light

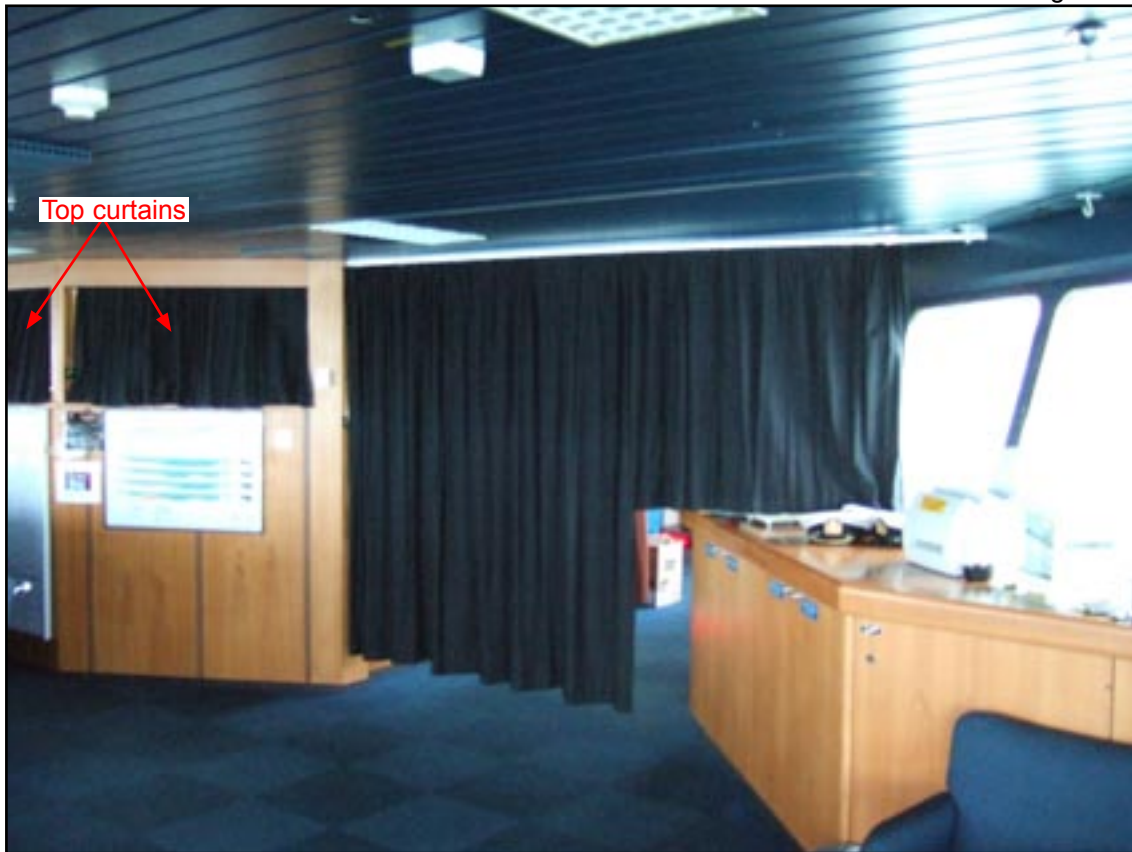
Figure 10

Port side chartroom black out curtains

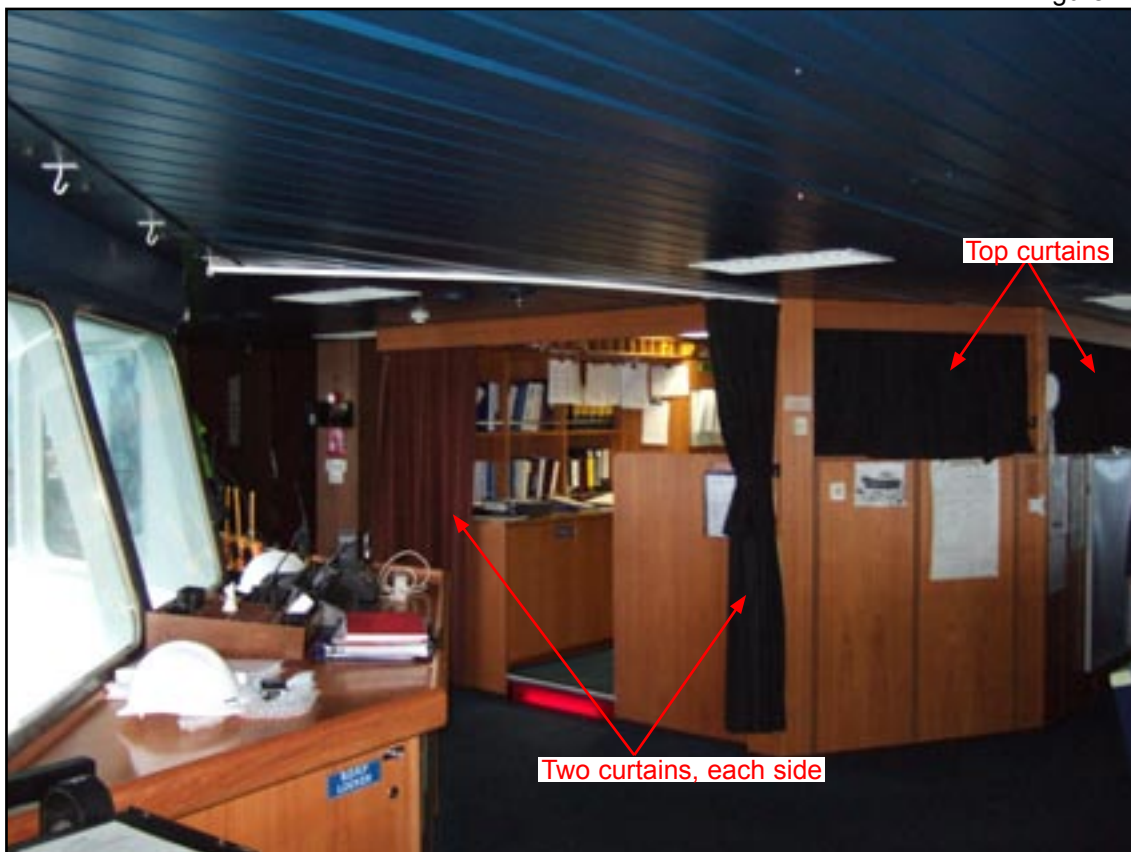
Figure 11

Starboard side curtains, and port side were in open position as shown

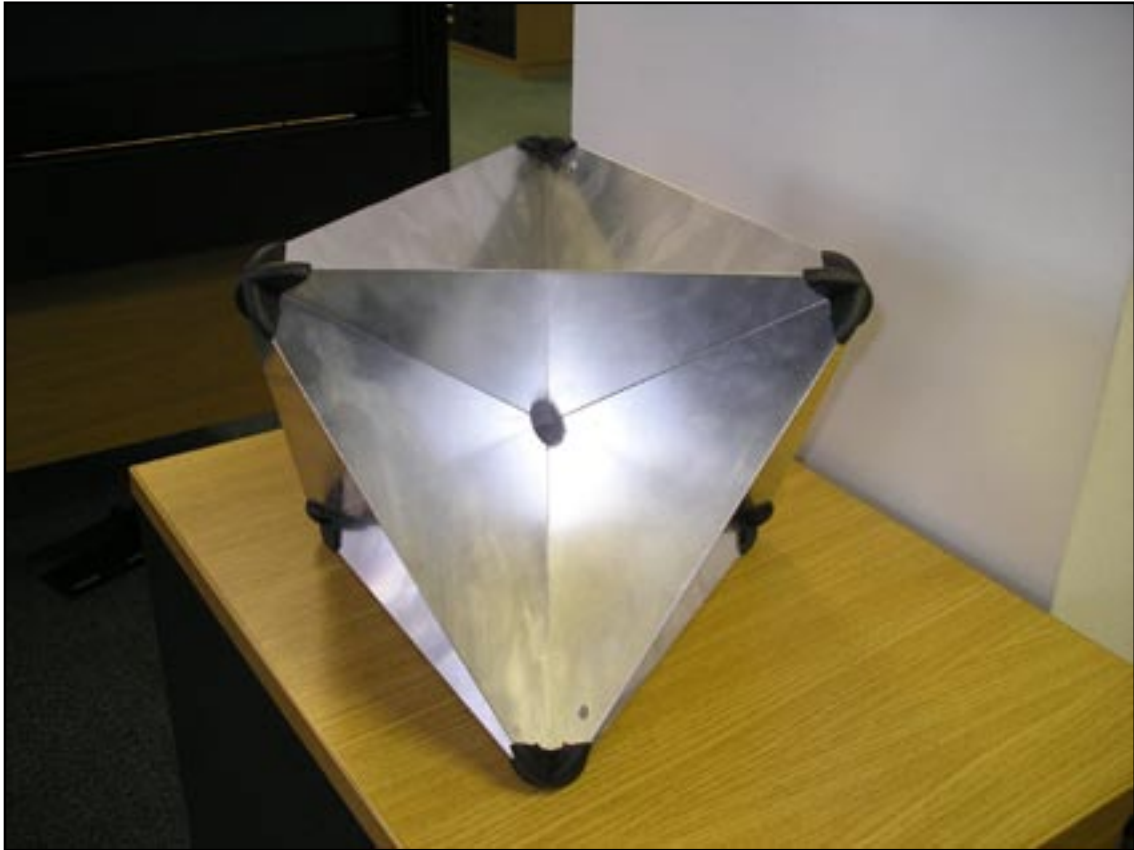
Figure 12

Octrahedral type radar reflector ("catch rain" position)

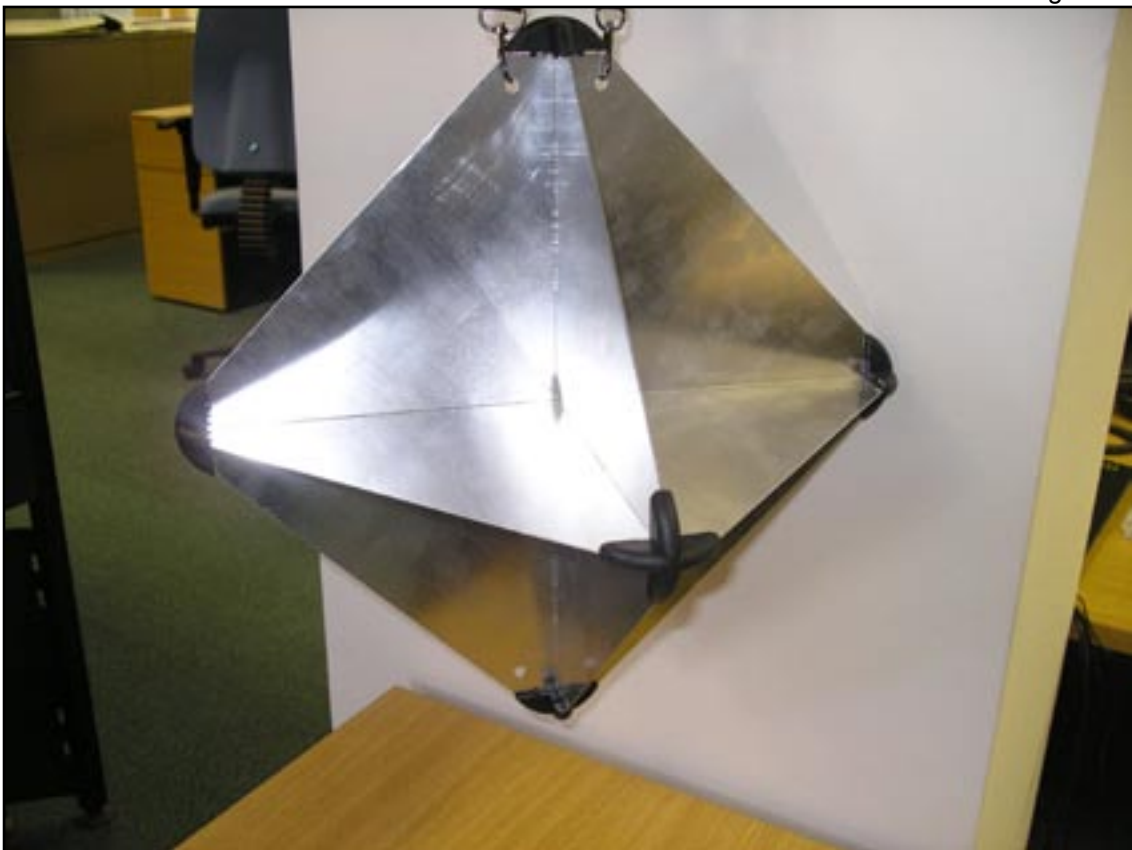
Figure 13

QinetiQ Funtington’s report (**Annex 4**) concluded that, bearing the above factors in mind, it was unlikely that deployment of the radar reflector on *Ouzo* would have made very much difference to the RCS of the yacht.

Radar reflector (not in "catch rain" position) suspended from the fixing points

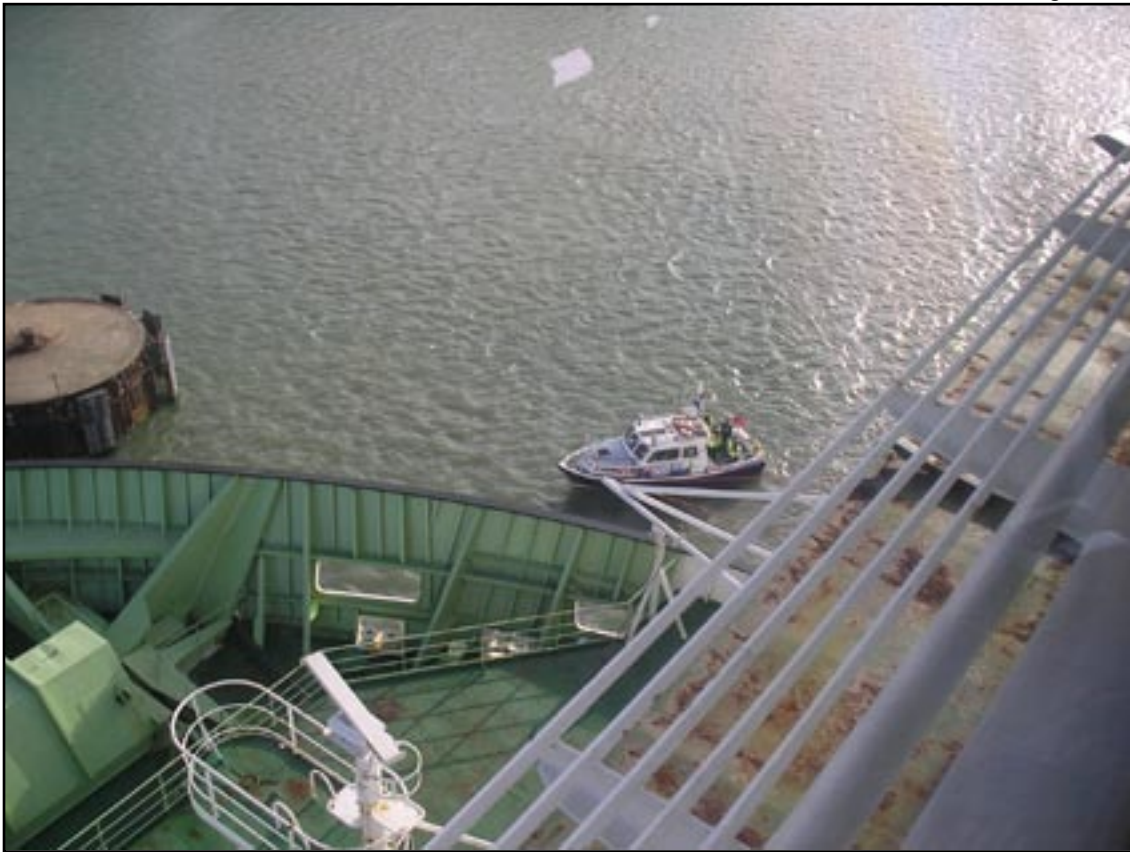
Figure 14

It is the firm view of the MAIB that a passing distance of 30 metres or less was unsafe for a small yacht in this situation.

Approximate position of *Ouzo* as she passed by

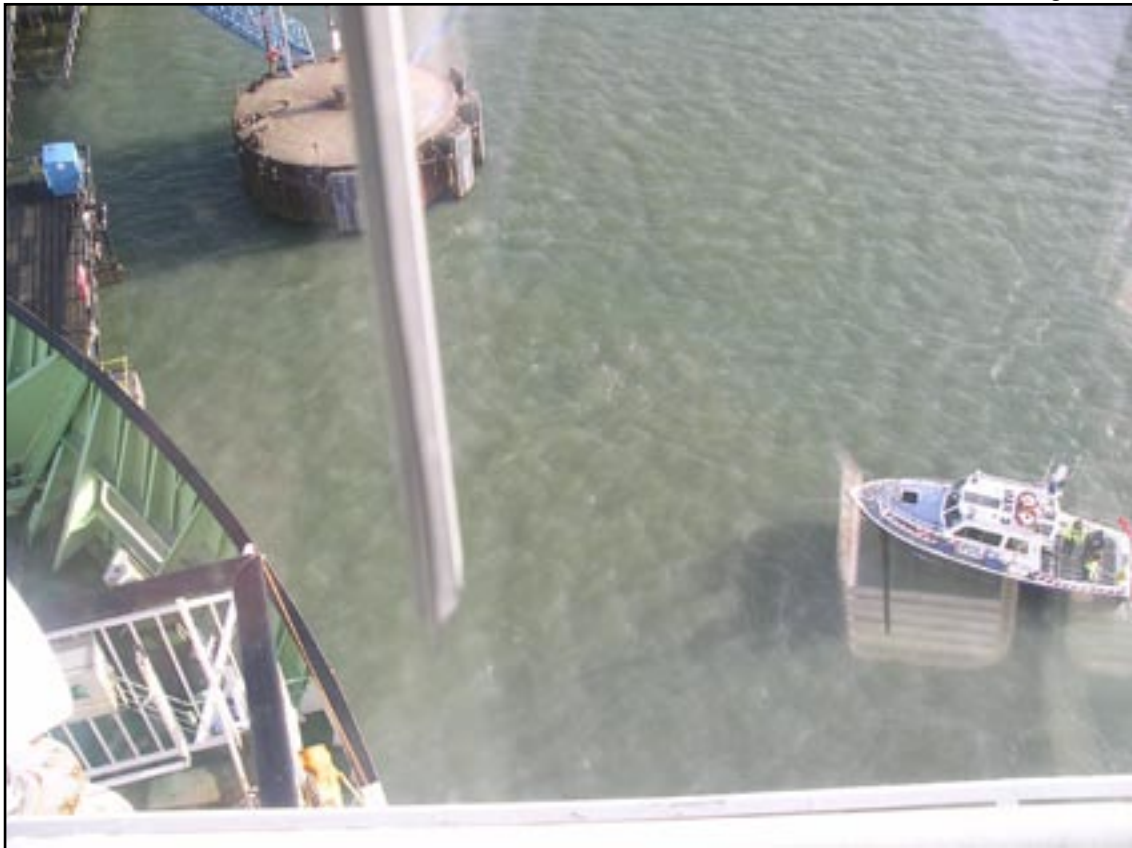
Figure 15

Approximate position of *Ouzo* looking down from starboard side of bridge

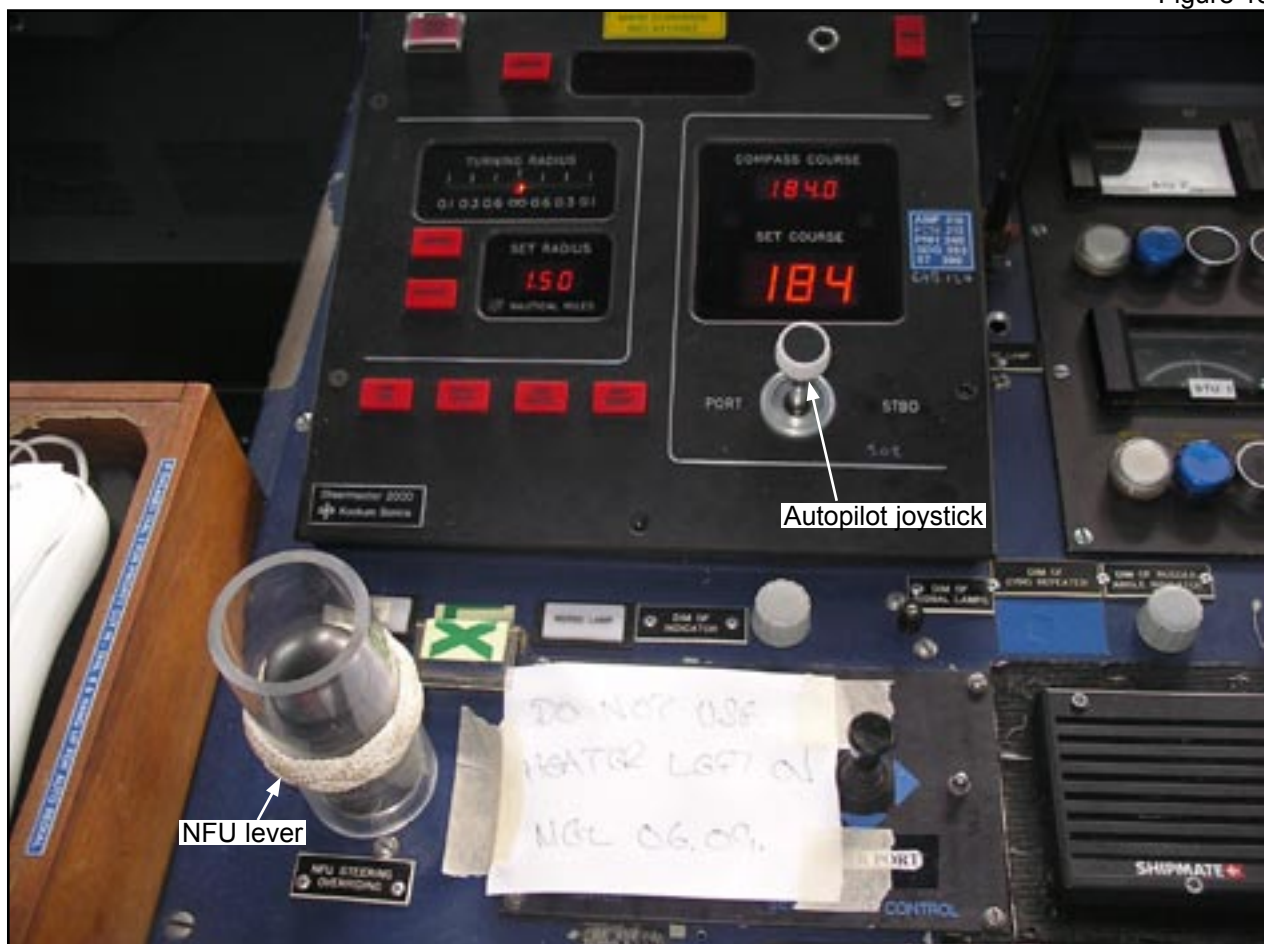
Figure 18

The second officer elected not to use either of these two steering modes, despite the fact that he considered that he urgently needed to turn the vessel quickly to port. Instead, he opted to keep the vessel in autopilot steering mode and adjust the course using the autopilot course input joystick (**Figure 18**).

NFU and autopilot joystick
