Report on the investigation of the loss of the sailing yacht

***Ouzo***

South of the Isle of Wight

**Report No 7/2007**  
**April 2007**

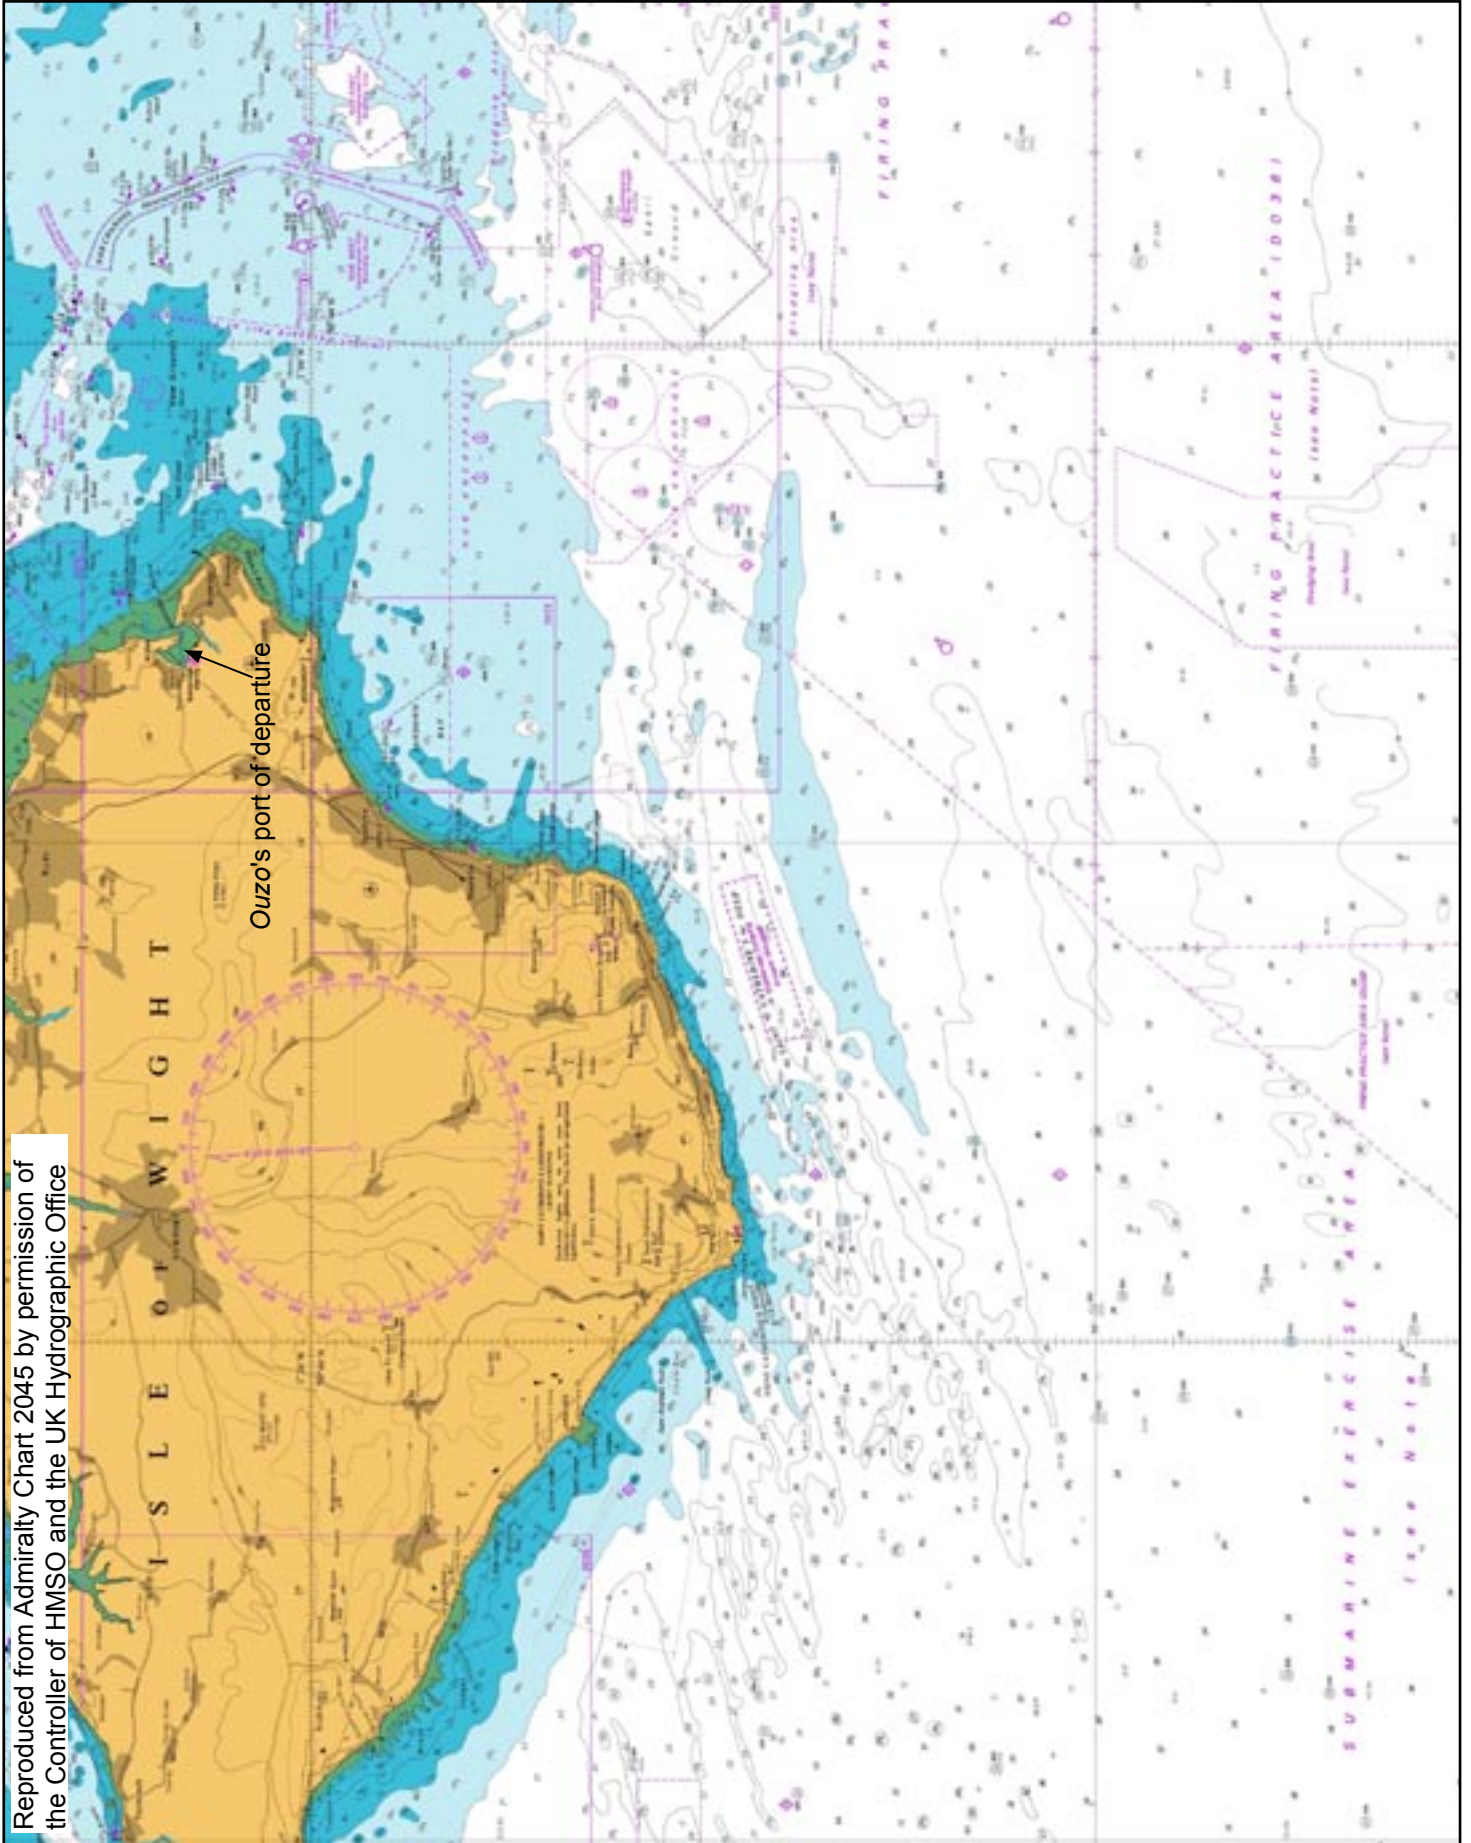
Figure 2

While there is conflicting evidence over the exact time of *Ouzo*'s departure from Bembridge, it would appear that she left her mooring at about 2030 that evening, and sailed out of the harbour under power, arriving off Saint Helen's Fort at 2105. The evidence then indicates that the crew raised the sails and sailed in a southerly direction down the east coast of the Isle of Wight (**Figure 2**).

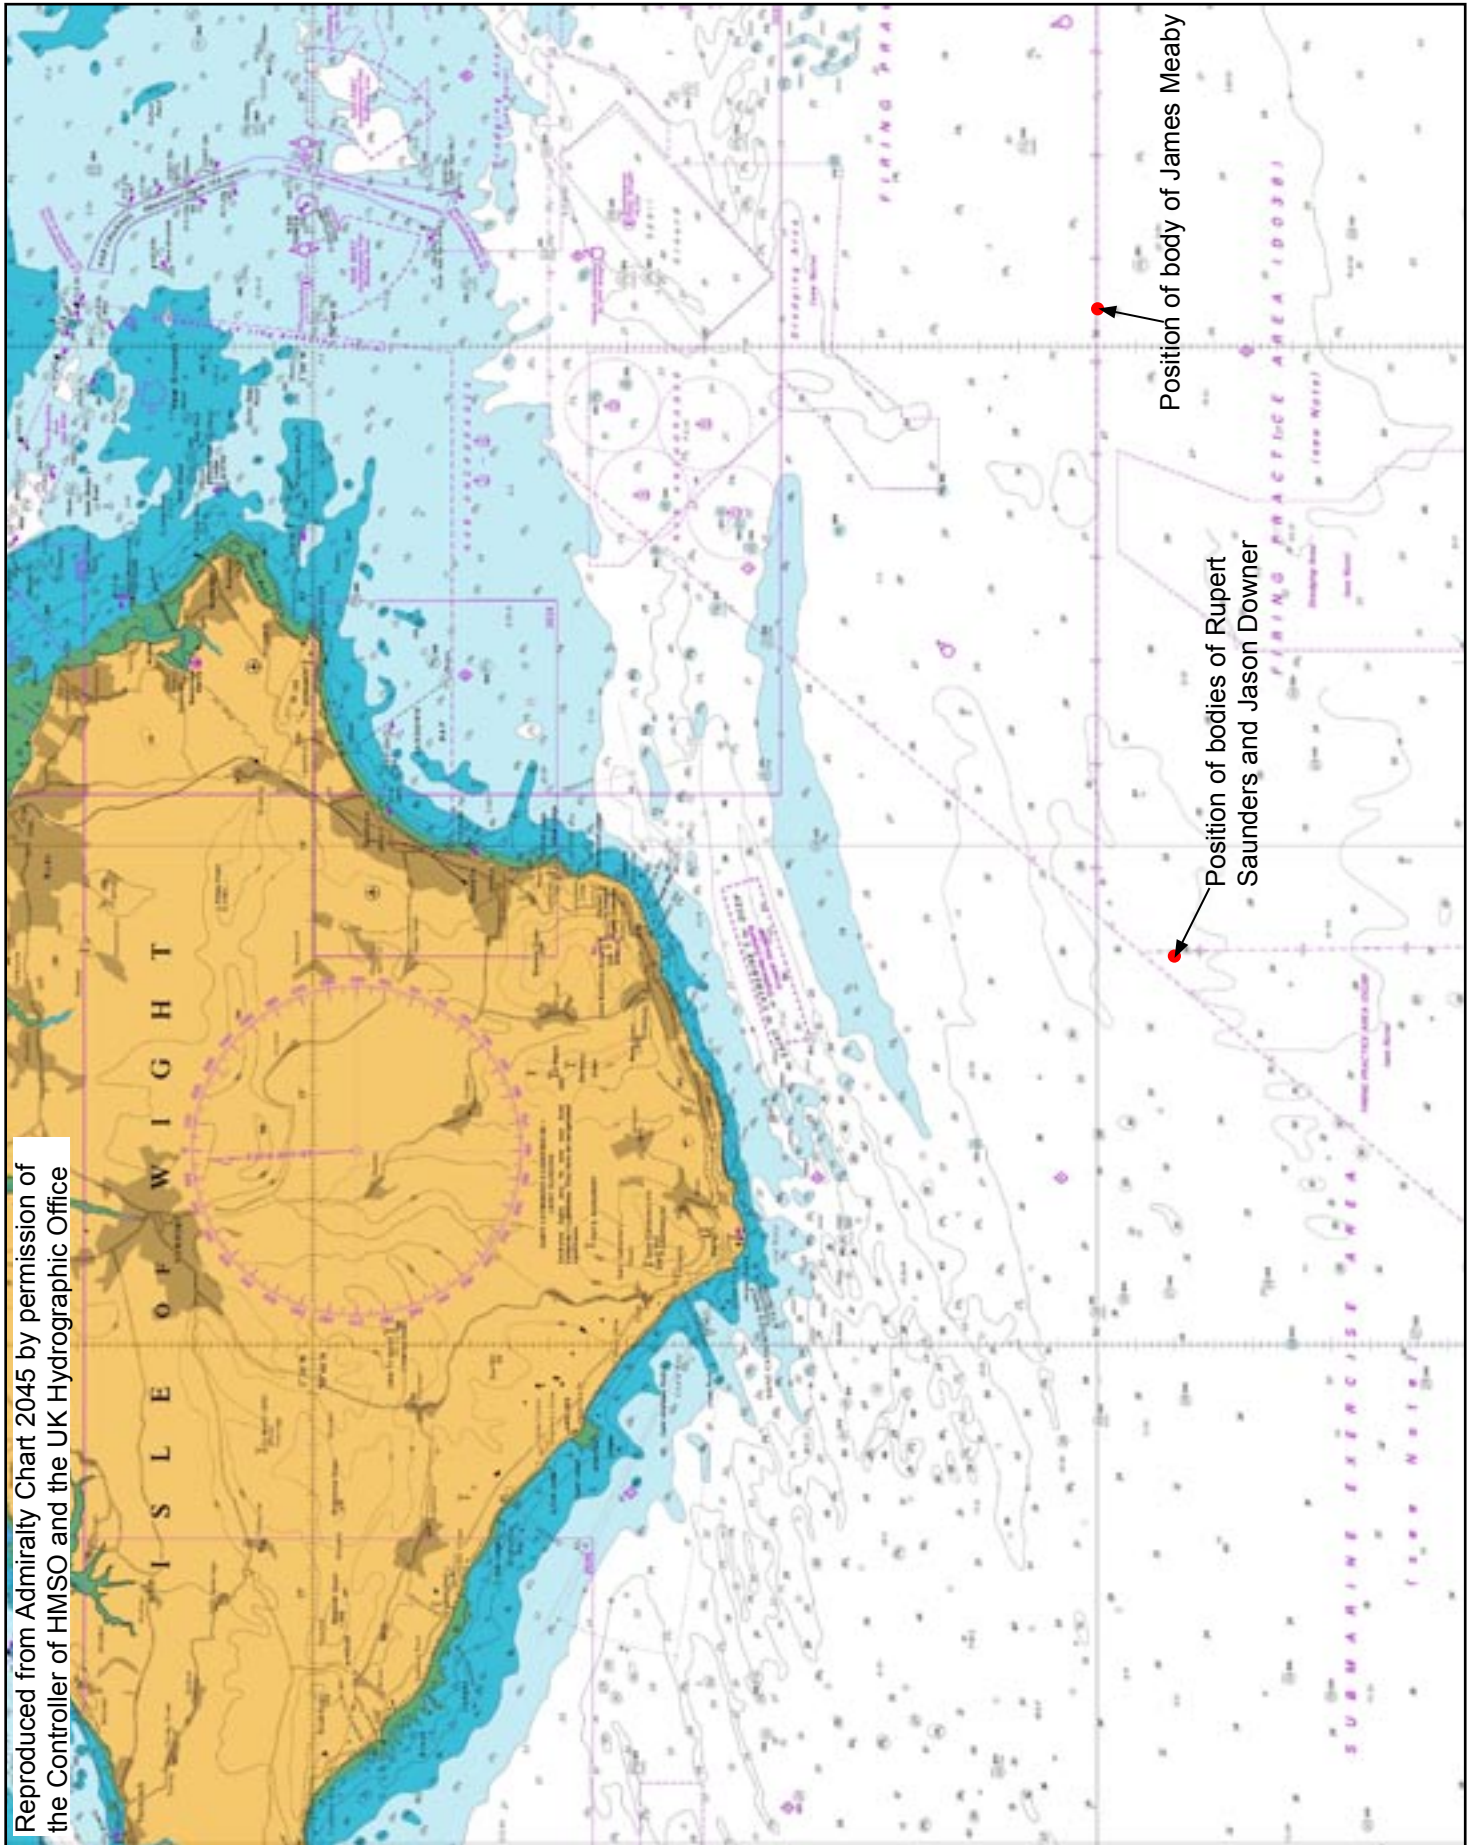
Figure 3

At just before midday on 22 August, 40 hours after the yacht had left Bembridge, the body of a man was found in the sea about 10 nautical miles south of the Nab Tower (**Figure 3**). He was wearing a manually inflated lifejacket and yachtsman's clothing.

At about 1900 in the evening of 23 August, the bodies of Jason Downer and Rupert Saunders were recovered from the sea about 10 nautical miles south-west of the Nab Tower (**Figure 3**).

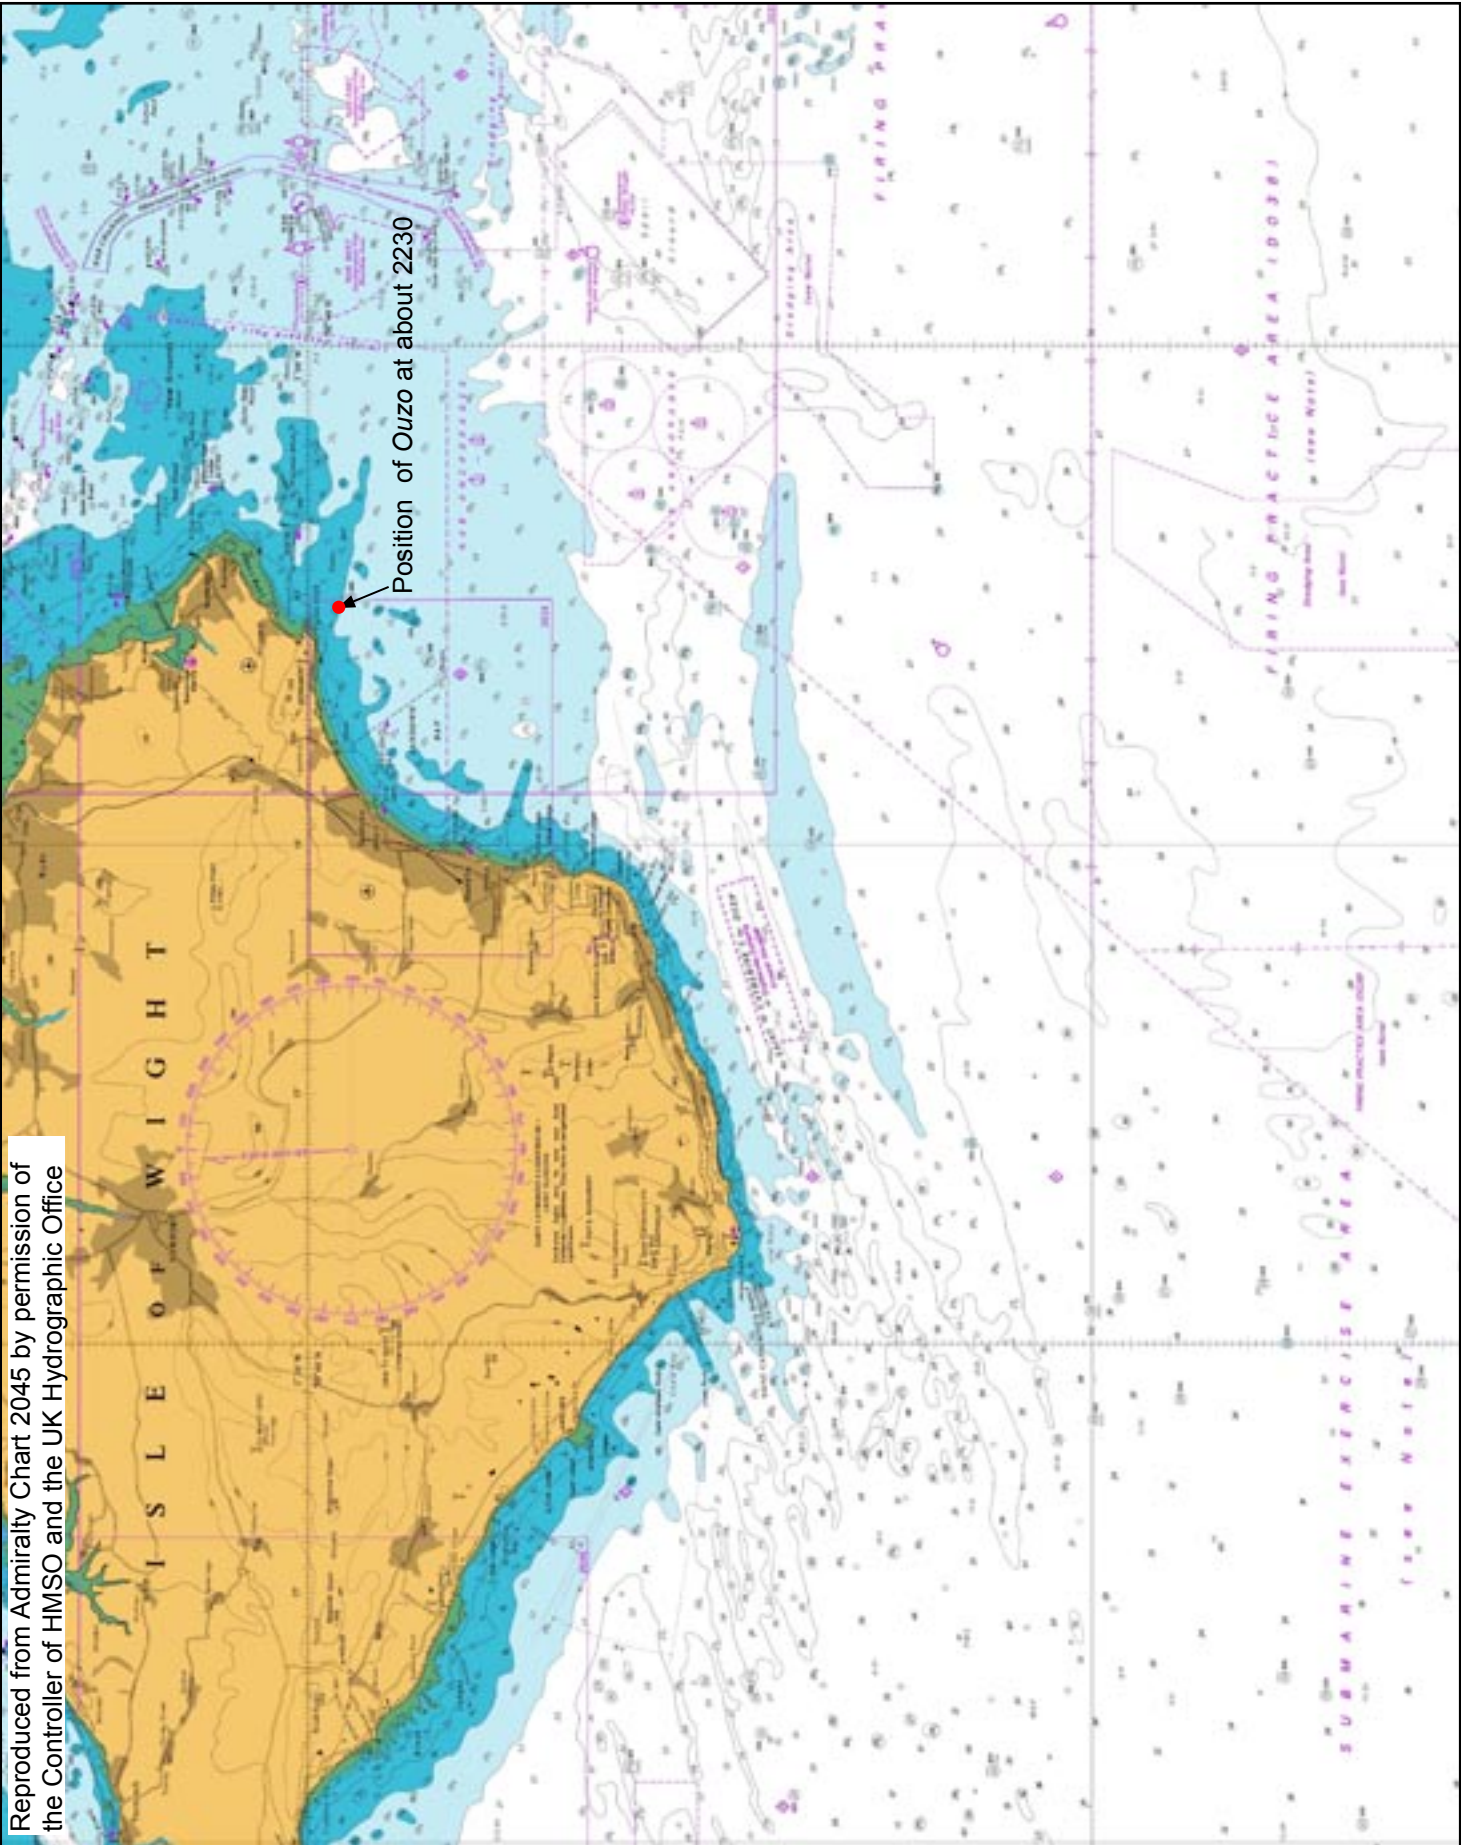
Figure 6

The view that the target, which was lost at about 2230 in Sandown Bay, was that of *Ouzo* was reinforced further when investigations indicated that one of the crew had made a mobile phone call from the yacht shortly after that time. Triangulation of the mobile phone signal data had shown that the vessel was in Sandown Bay when the call was made (**Figure 6**).

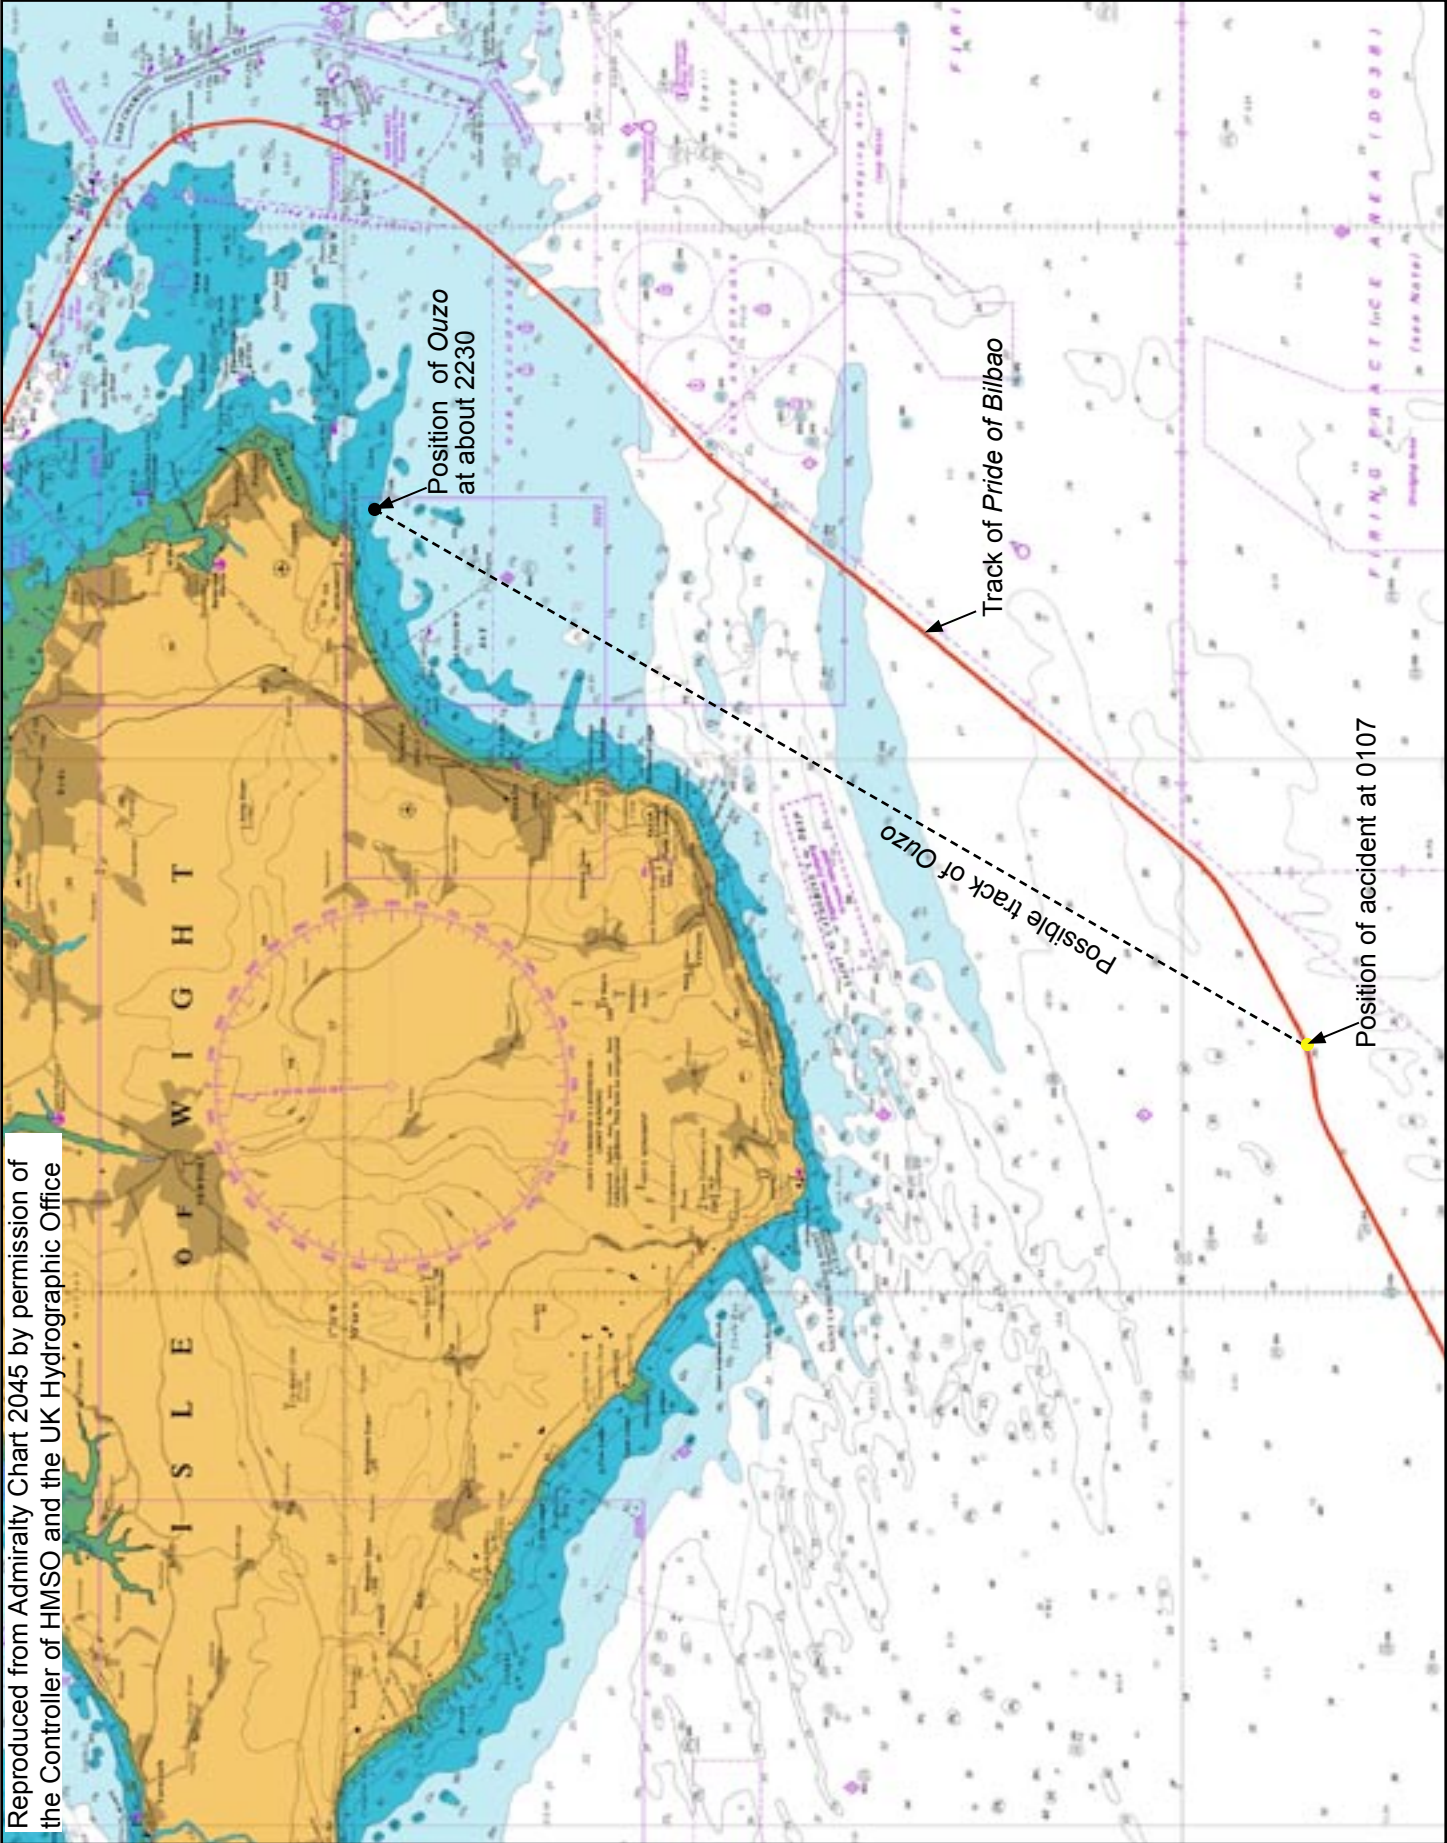
Figure 7

At that time, the tide was starting to be favourable and the wind was west-south-westerly force 5. For *Ouzo* to have been close to *Pride of Bilbao* at 0107 she needed to have covered a distance of 13.3 nautical miles in a south-south-westerly direction from her 2230 position. This equates to a ground speed of about 5 knots. Both the course and speed required to achieve this are entirely feasible for *Ouzo* given the prevailing environmental conditions (**Figure 7**).

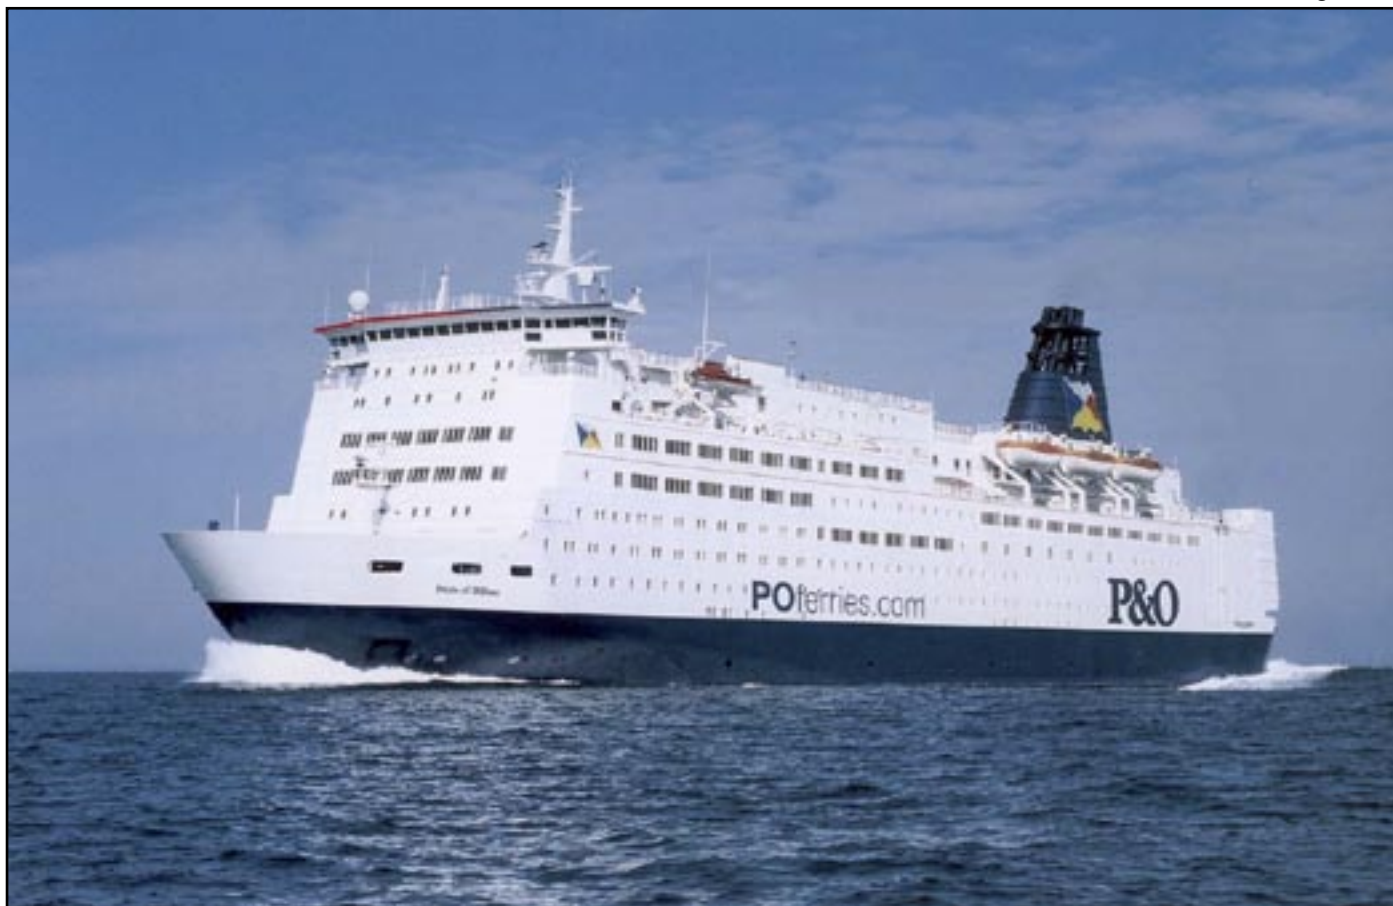
Approximate position of *Ouzo* looking down from starboard side of bridge

*Pride of Bilbao's bow wave and trailing stern wake*

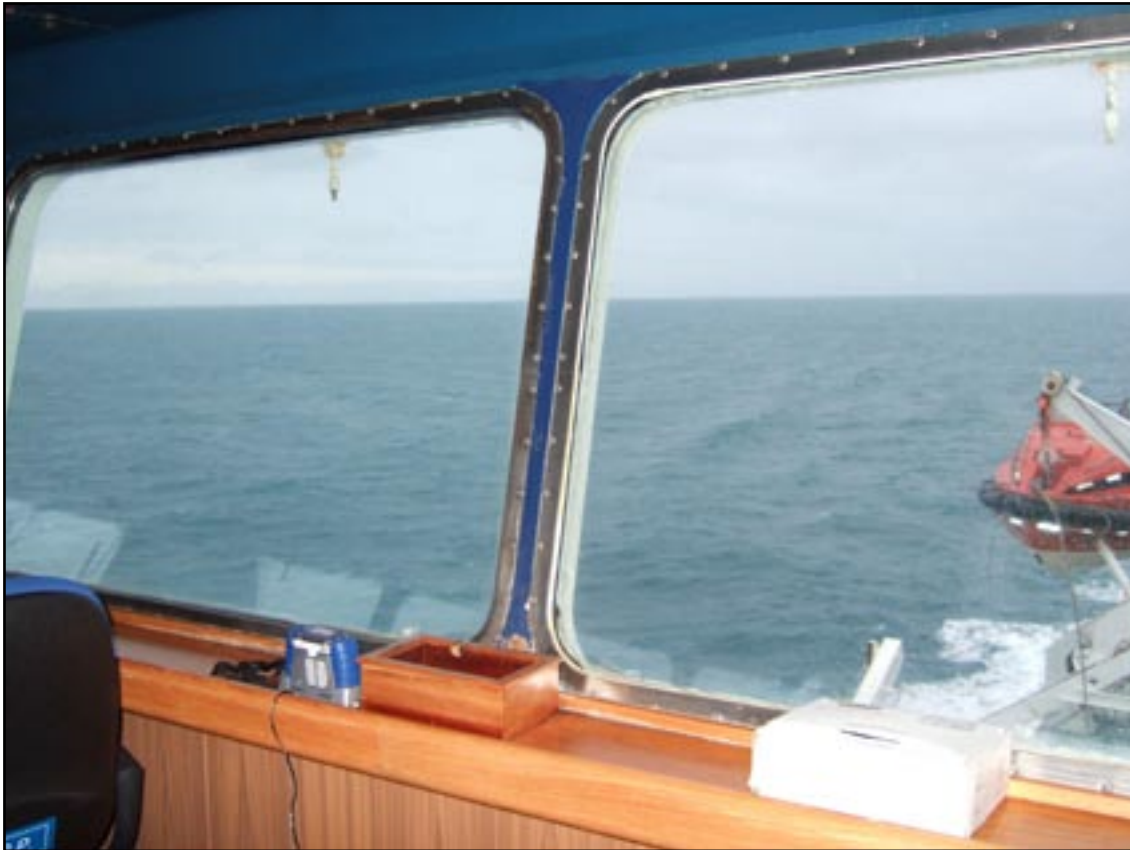
Figure 17

The lookout had run across the bridge to the starboard side as the yacht passed from view to determine where it was. At first, he did not see the yacht or her lights, probably because he was not looking from the extreme outboard vantage point on *Pride of Bilbao's* bridge, but a few metres inboard. From his position he would only have been unable to see a boat that was very close alongside the hull (**Figures 17 and 17a**).

View from inboard starboard side

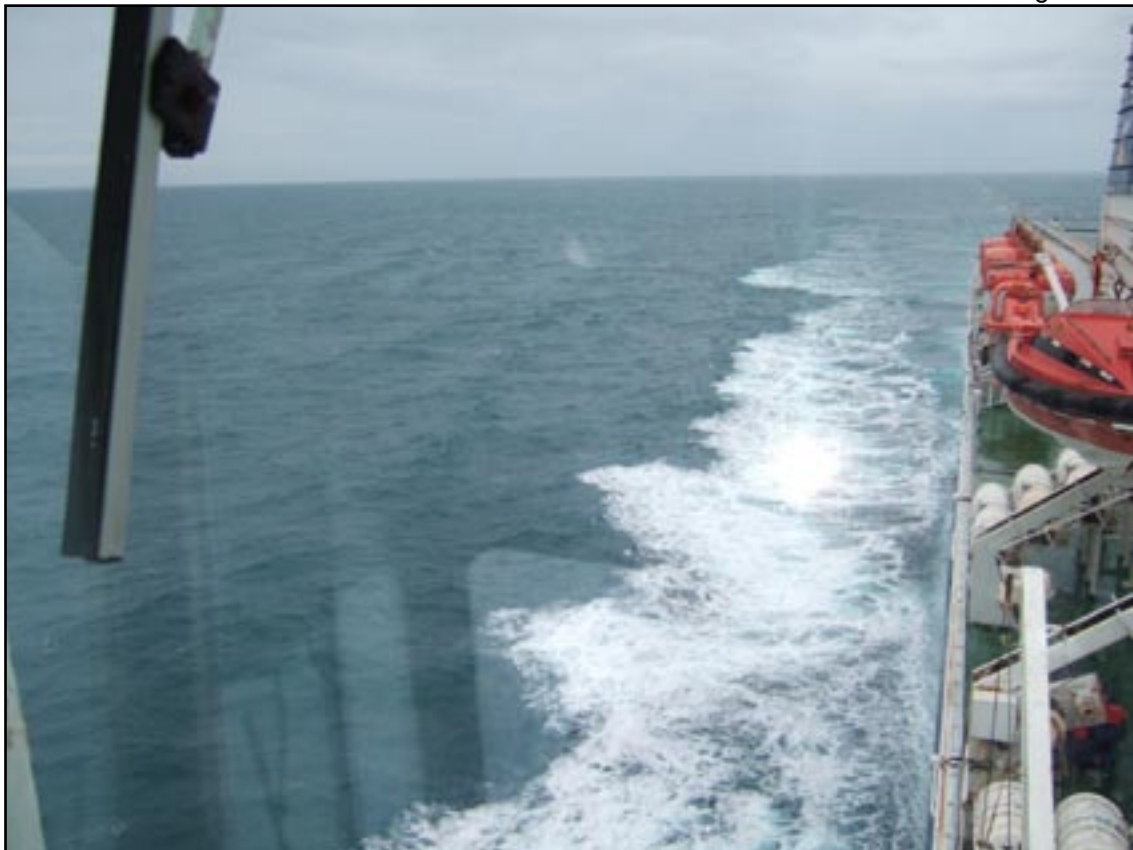
Figure 17a

View aft from extreme starboard side
